APPENDIX D

VALLEY AND FLOODPLAIN MORPHOLOGY ANALYSIS

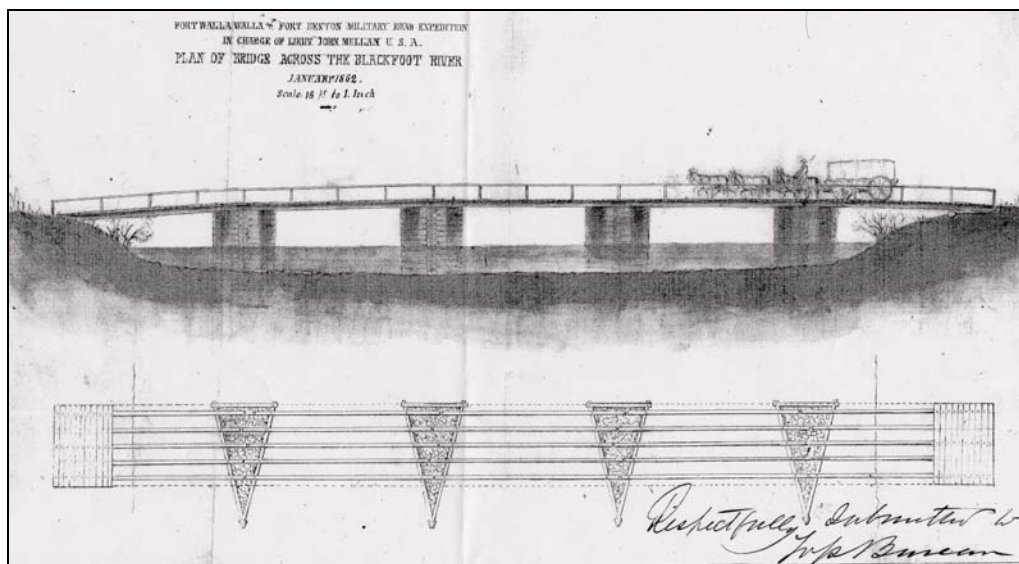
Figure D-1. The Military Road crossing on the Blackfoot River drawn under the guidance of Lieutenant John Mullan in 1862. Image provided by the National Archives (File: RG 77 Rds. 174-6).

The Mullan expedition established a camp at the CFR-BFR confluence in the winter of 1860 and 1861 during the construction of the Military Road. The Military Road (later called the Mullan Road) was to link Fort Walla Walla on the Columbia River, with Fort Benton on the Missouri River at distance of 640 miles. Reaching Cantonment Wright at the CFR-BFR confluence on November 22, 1860, Mullan divided his men into five groups. The first group remained at the confluence to construct a bridge over the BFR near the confluence (Figure D-1). The other groups were distributed in winter camps along the CFR from present-day Turah to Beavertail Rock (Kolecki, 1863) at locations where hill slope cuts were to be made in an effort to minimize the number of necessary river crossings (Mullan, 1863).

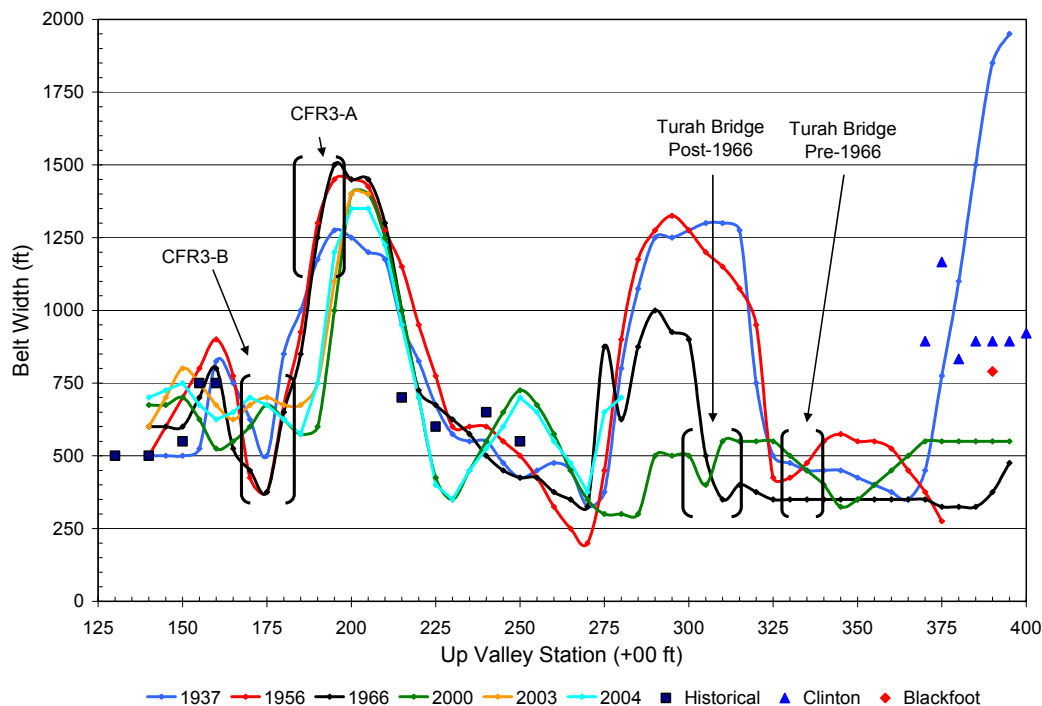
Figure D-2. Planform belt width by photograph series through the CFR3 study area. Comparative points are also presented for the Clinton Reach and the Ovando C Reach.

Historical meander scrolls identified in the CFR near Milltown Dam in the 1937 floodplain (station 215+00 through 250+00), likely represented a pre-disturbance condition and were found to have belt width dimensions similar to the CFR3-B reference reach. Additional abandoned meanders identified within the active 1937 floodway (station 130+00 through 150+00 and station 155+00 through 160+00), also displayed a range of intermediate belt width values.

Belt widths measured on the CFR near Clinton were found to have higher values than the downstream CFR3-B and historical meander values, but belt width values were less than the values measured in the braided reaches. The Ovando C reference reach also exhibited intermediate belt width values.

Average CFR meander belt width ranged from a minimum of 608 ft to a maximum of 928 ft (Table D-2). The historical scrolls represented minimum values while the Clinton reach contained maximum average values. Similar belt width results were noted between the BFR Ovando C reach and the 1937 CFR3-B reference reach, 790 ft and 825 ft, respectively. The 2004 CFR3-B reference reach and the remnant channel segments also displayed similar belt width values, 608 ft to 618 ft, respectively. The Clinton reach had a belt width of 928 ft.

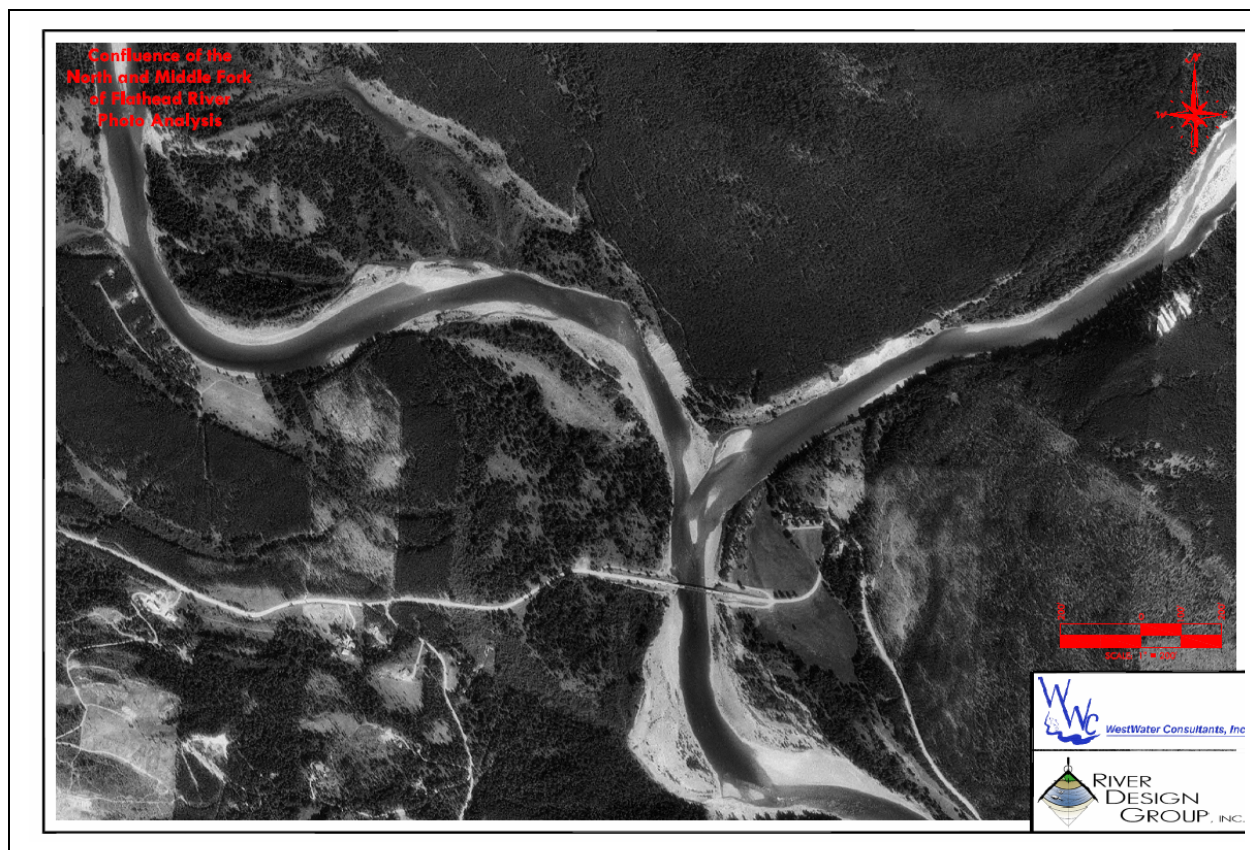
Figure D-3. Confluence of the North Fork Flathead River with the Middle Fork Flathead River near Columbia Falls, MT.

The North Fork Flathead River-Middle Fork Flathead River confluence is geomorphically similar to the CFR-BFR confluence. The North Fork Flathead is a Type VIII valley similar to the CFR upstream from the confluence. The Middle Fork Flathead is a Type II valley, similar to the BFR. Downstream from the confluence, both rivers transition into a more confined valley type. Both confluences are low gradient, alluvial, gravel bed rivers with numerous impacts and disturbances upstream. The Flathead system has had several large floods over the past four decades. As indicated in Figure D-3, both forks of the Flathead River currently have meandering morphology that continues downstream.

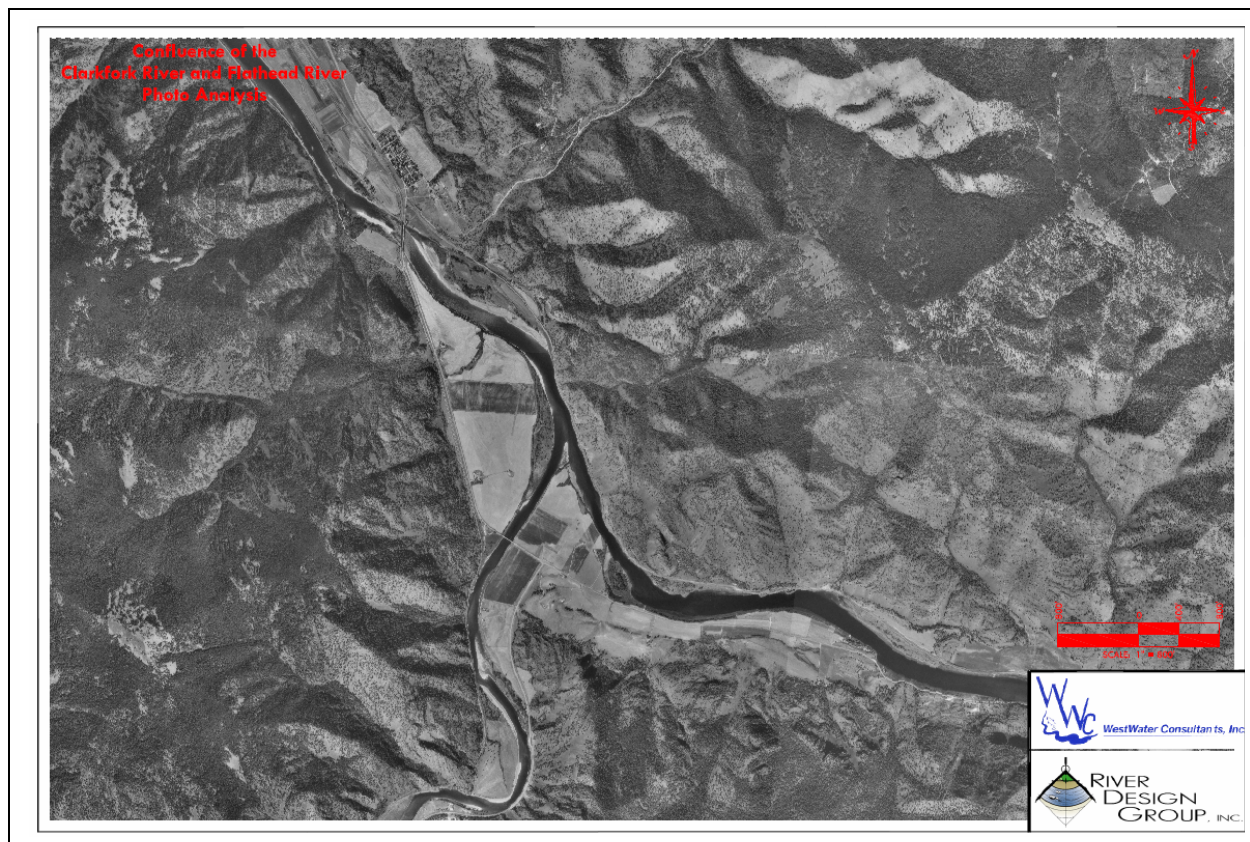
Figure D-4. The confluence of the Clark Fork River and Flathead River near Paradise, MT.

The confluence of the Clark Fork River with the Flathead River is another example of similar rivers converging without apparent braiding or anabranching (Figure D-4). Like the previous example, both rivers are low gradient systems with the Flathead River located in a large, unconfined valley while the CFR is moderately confined. Downstream of the confluence, the CFR transitions to a moderately confined valley type. Both rivers have numerous impacts upstream and have experienced large floods over the last several decades.

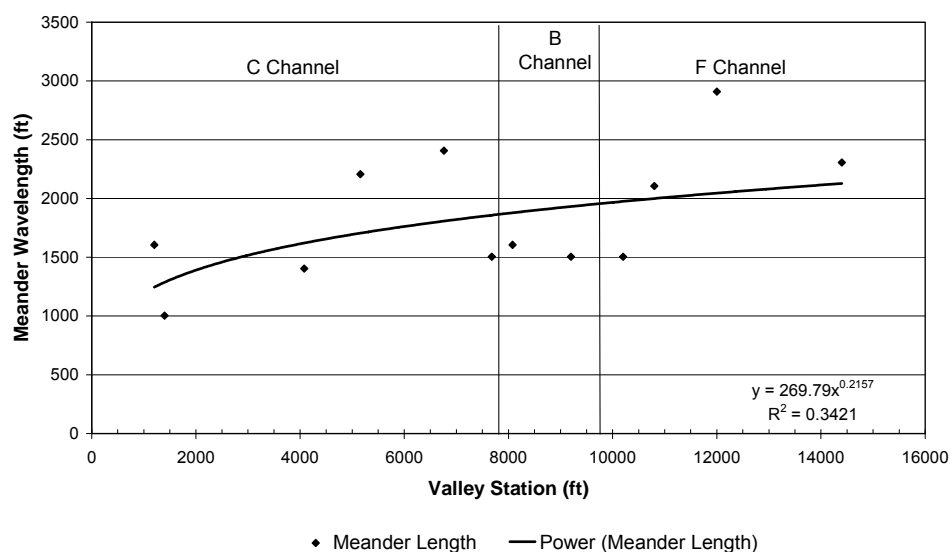
Figure D-5. Meander wavelength relative to valley stationing and stream type for the BFR Ovando reference reach.

The meander wavelength generally increased in a downstream direction from the C stream type to the F stream type (Figure D-5). While the BFR in the C channel reach was free to laterally migrate, the F channel reach was structurally controlled. The distance between consecutive meanders increased as the channel was increasingly confined by the valley as the valley transitioned from a Type VIII valley a Type II valley to a Type IV valley.

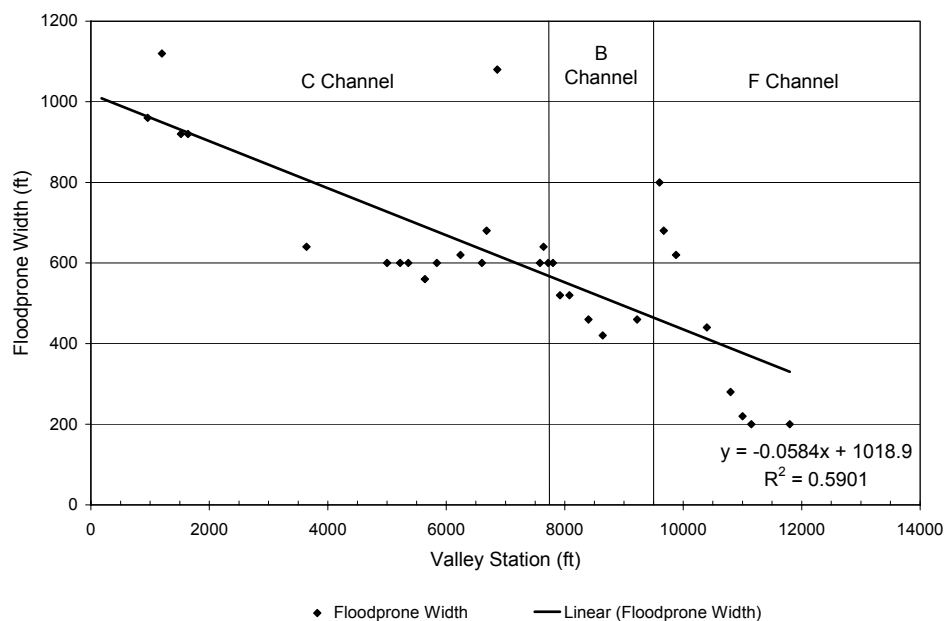
Figure D-6. Floodprone width relative to valley stationing and stream type for the BFR Ovando reference reach.

The floodplain area as measured by the floodprone width also exhibited a down-valley trend. As the BFR transitioned from the unconfined Type VIII valley in the C reach to the structurally controlled Type II valley in the F reach, the floodprone width narrowed. This morphological trend was expected based on the valley types. However, instead of a smooth, consistent narrowing of the floodplain through the B transition reach and into the entrenched F reach, the floodplain widens substantially at the beginning of the B and F reaches (Figure D-6). The data

points illustrate this condition with a momentary increase in floodplain width at each transition, then narrowing again in the downstream direction. Meanders occur at each of these transitions and may encourage flooding of the opposite bank during high flows.

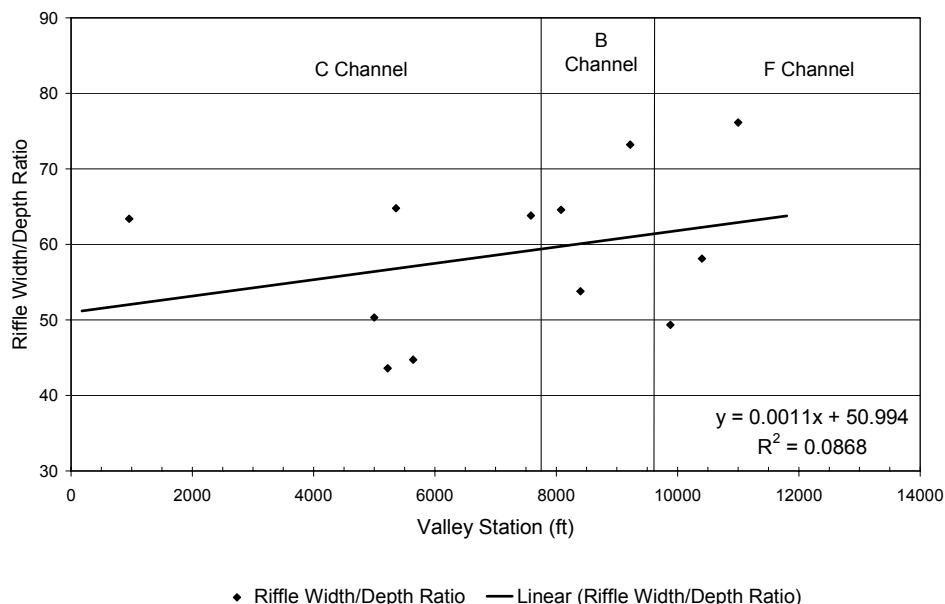
Figure D-7. The riffle width-to-depth ratio relative to valley stationing and stream type in the BFR Ovando reference reach.

There was also a notable increasing trend in the riffle width-to-depth ratio in a down-valley direction (Figure D-7). As the floodplain narrows width-depth ratios increase. Lower values occur upstream in the C reach and maximum values occur downstream in the F reach. The transitioning B reach was characterized by intermediate width-to-depth ratio values. Although a relatively strong trend was detected, substantial variation in width-to-depth ratio exists within each reach. The channel width-to-depth ratio likely relates to the influence of flood flows that scour the channel. In the slightly confined C reach, flood flows access the adjacent floodplain and the stream energy is dissipated. In the entrenched F reach, flood flows are maintained within the active channel and there excess stream energy available to scour the channel.

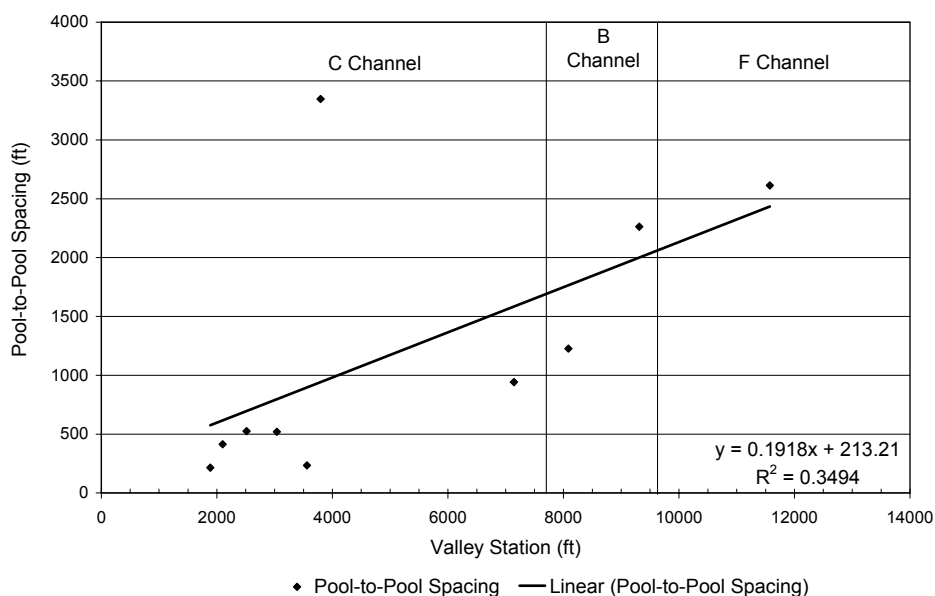
Figure D-8. The pool-to-pool spacing as measured by the distance between pools, relative to valley stationing and stream type in the BFR Ovando reference reach.

Pool spacing increased in the downstream direction through the valley transition suggesting greater stream energy in the confined F reach (Figure D-8). The shortest spacing was observed in the upstream meandering C reach where nine pools occurred, and minimum values obtained in the downstream F reach where two pools exist. Within the transition B-reach, one pool was noted.
